ELECTRONIC COMPUTING HOME OPERATOR - Designed by James F. Sutherland

TABLE OF CONTENTS

Tab
News Clippings	1
ECHO IV Instruction Set	2
ECHO IV Log Book I (14 Apr 1966 - 19 Oct 1968)	3
ECHO IV Log Book II (19 Oct 1968 - 2 Oct 1974)	4
ECHO IV Back-panel Wiring Lists	5

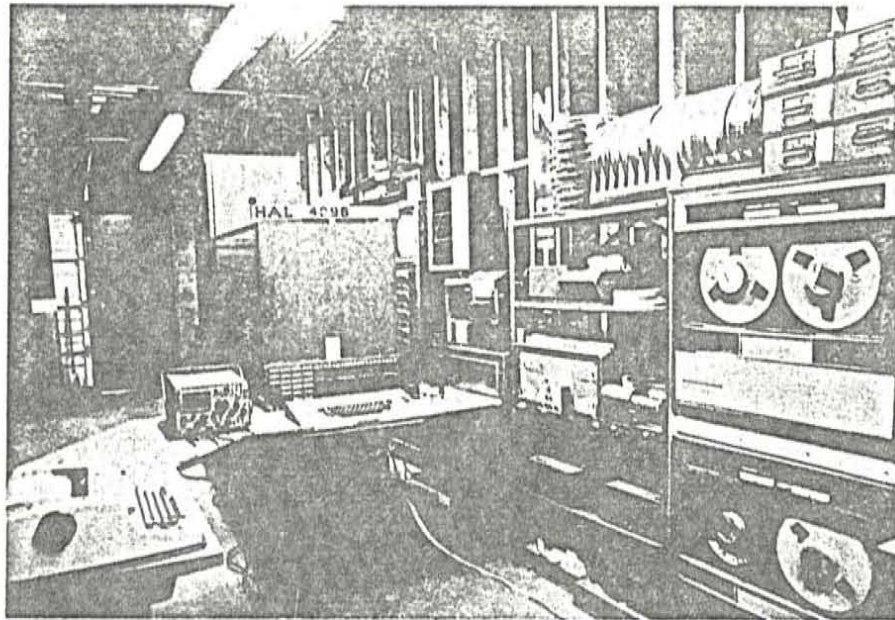
Photo 1: Hal Chamberlin's home built HAL-4096 computer system, built in 1972. This system, which is still in service handling IO for an IMP-16 micro-computer system, features TTL logic, a 16 bit word length, 16 registers, 4 K bytes of magnetic core memory (a surplus IBM 1620), and priority interrupt.

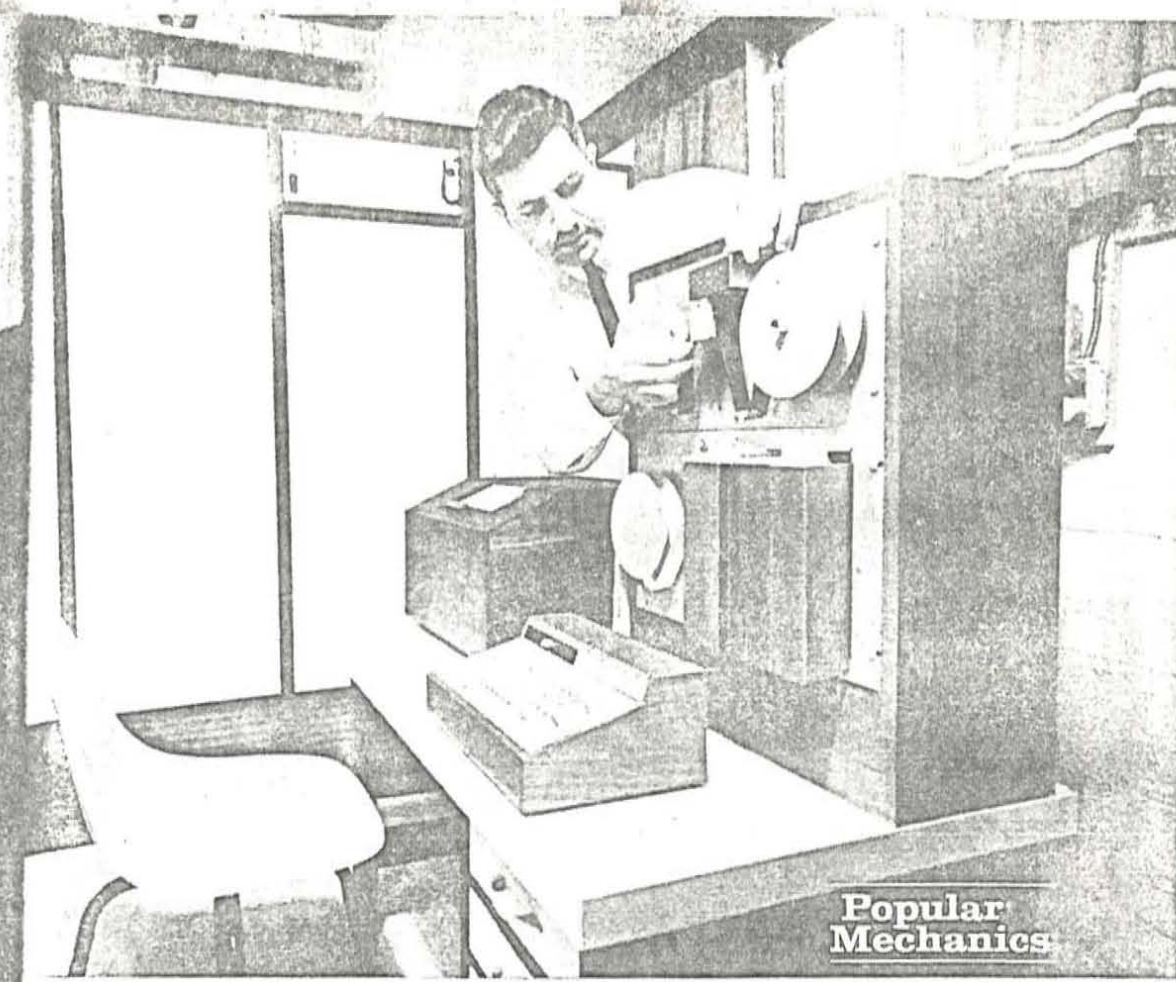
HOMEMADE PROGRAMMER'S DESK contains keyboard, page printer, paper tape punch and paper tape reader

capability. To overcome that handicap, Jim produced a programmer's desk consisting of a keyboard, page printer, paper tape punch, and paper tape reader in oiled walnut enclosures.

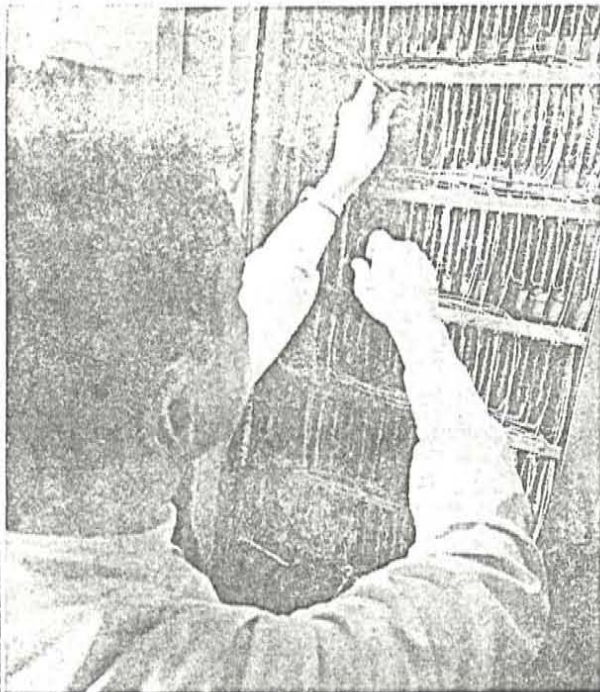
SUTHERLAND goes over the intricate wiring required to build ECHO. Each of four units has such a panel

gineer with Westinghouse Electric Corp., and his wife, Ruth, is a home economist. Their home-computer venture began two years ago when, as a hobby, Jim started buying obsolete computer parts and sketching logic circuit diagrams. Actual wiring of 11 printed-circuit module mounting panels began as soon as the design stage was completed. Within the year, ECHO was running simple programs but was limited by an inadequate input-output

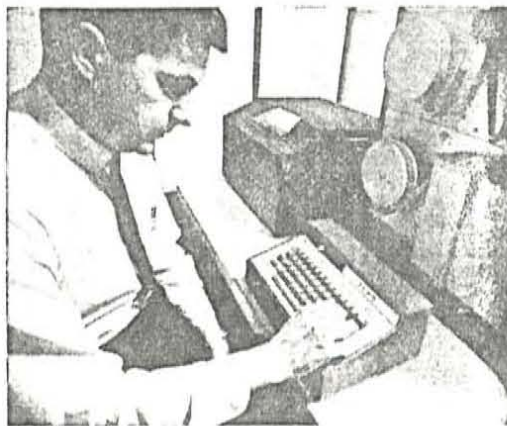
INPUT-OUTPUT UNITS are made from an electric typewriter keyboard and a surplus teletype printer

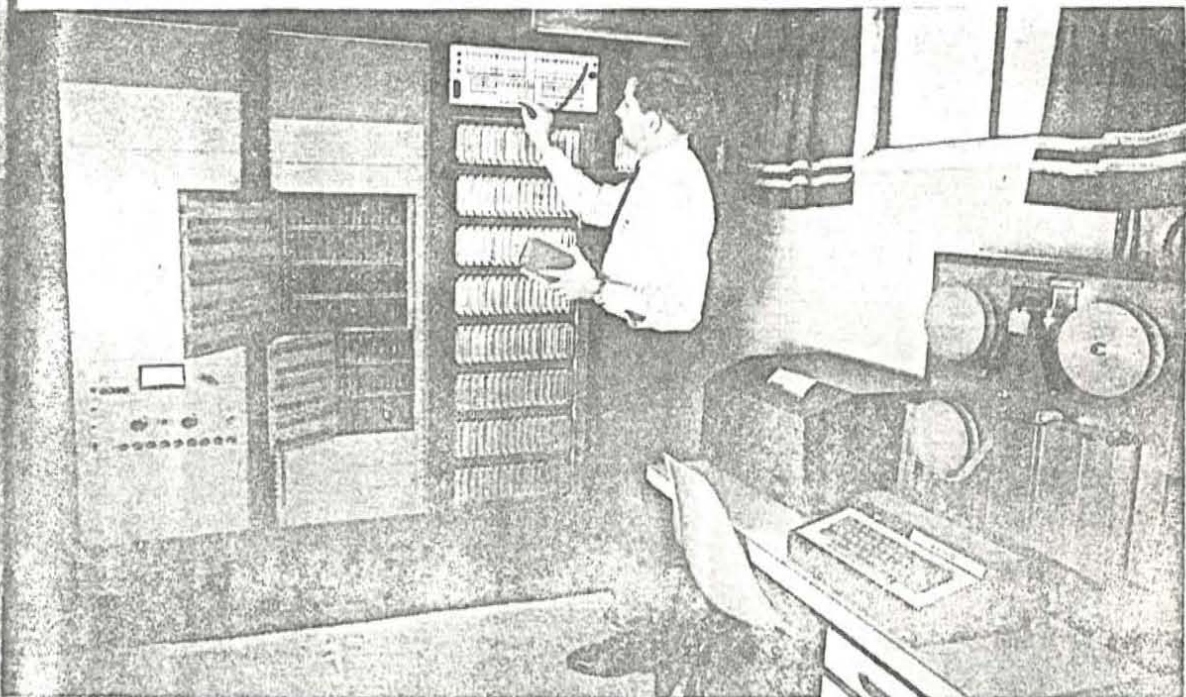
ECHO with two of the front panels removed. Computer takes about 20 square feet of basement floor space

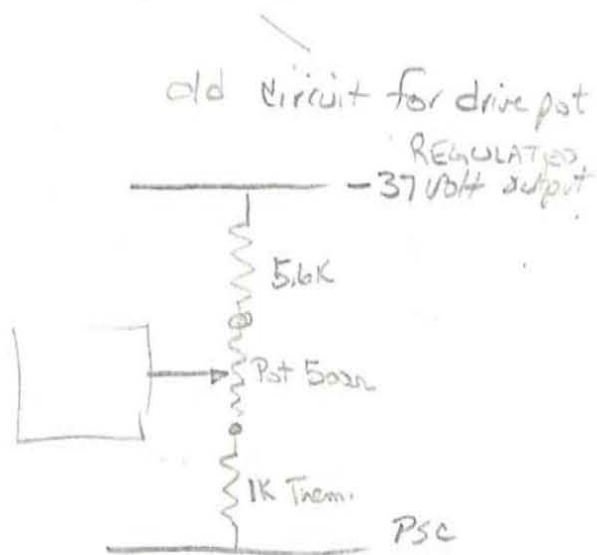
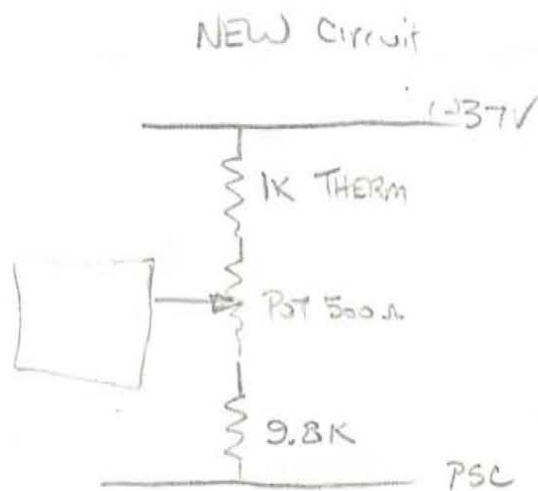
Since the -37 volt P.S. in memory system seems to oscillate when first turned on after being left off for several days, I decided to replace the regulator circuit. It was originally made of discrete components. The new regulator is a $\mu A723$. The 10 turn drive adj pot and Thermistor were rewired as shown below to provide control range of 32 - 37 volts. Drive voltage was set to 34 volts with dial setting of 7.5

(-) 37 Volt power supply in memory still sags to -30volts when first turned on after having been off for more than 24 hours. Trouble not due to excessive current (\approx 12 Amps) must be a leaky electrolytic capacitor which must reform each time power is restored after long period of inactivity.

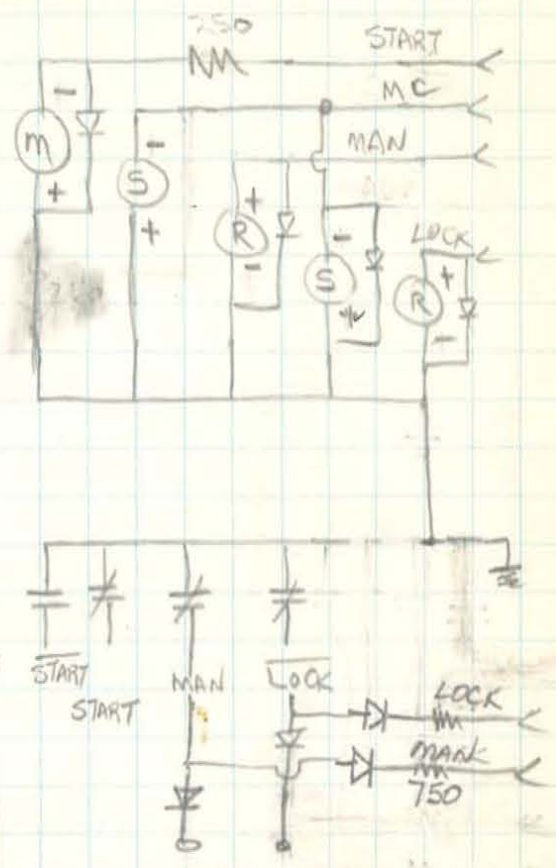
RELAY

NEW PB/RELAY ARRANGEMENT MAINTENANCE PANEL
